# An Integrated Approach to Initiate Preventive Strategies for Workers Exposed to Teflon Pyrolytic Gases in a Plastic Industry

(J Occup Health 2000; 42: 297–303)

**Key words:** Teflon, Pyrolytic gases, Accident investigation, Preventive strategy

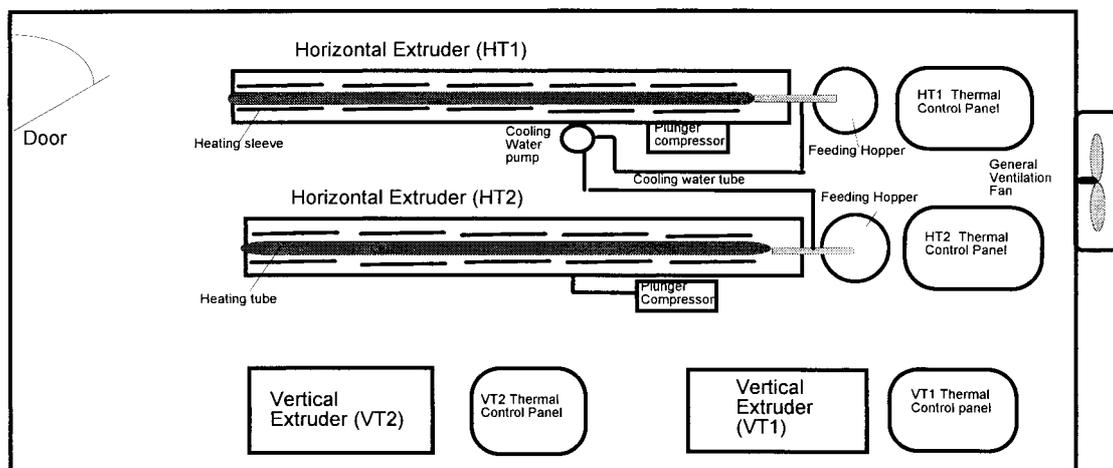
Fig. 1. The layout of the Teflon room.

be released from the end of heating tube, but could be generated in the heating tube, and delivered via the throat to the feeding hopper, and then finally released into the workplace atmosphere. Since a general exhaust fan was installed on the wall near the hopper of the HT<sub>2</sub> extruder (see Fig. 1), it was expected that workers working around the hopper might be exposed to higher concentrations than workers who worked elsewhere. It is therefore not surprising that molder A who worked near the hopper would be most exposed and died after the event, whereas molder B and the foreman who were not restricted to being near the hopper were hospitalized but recovered.

- a. Installing a local exhaust ventilation system in addition to the general exhaust ventilation system that is currently used in the Teflon room.
- b. Checking the flow rate of the cooling water system at the beginning of each work shift.

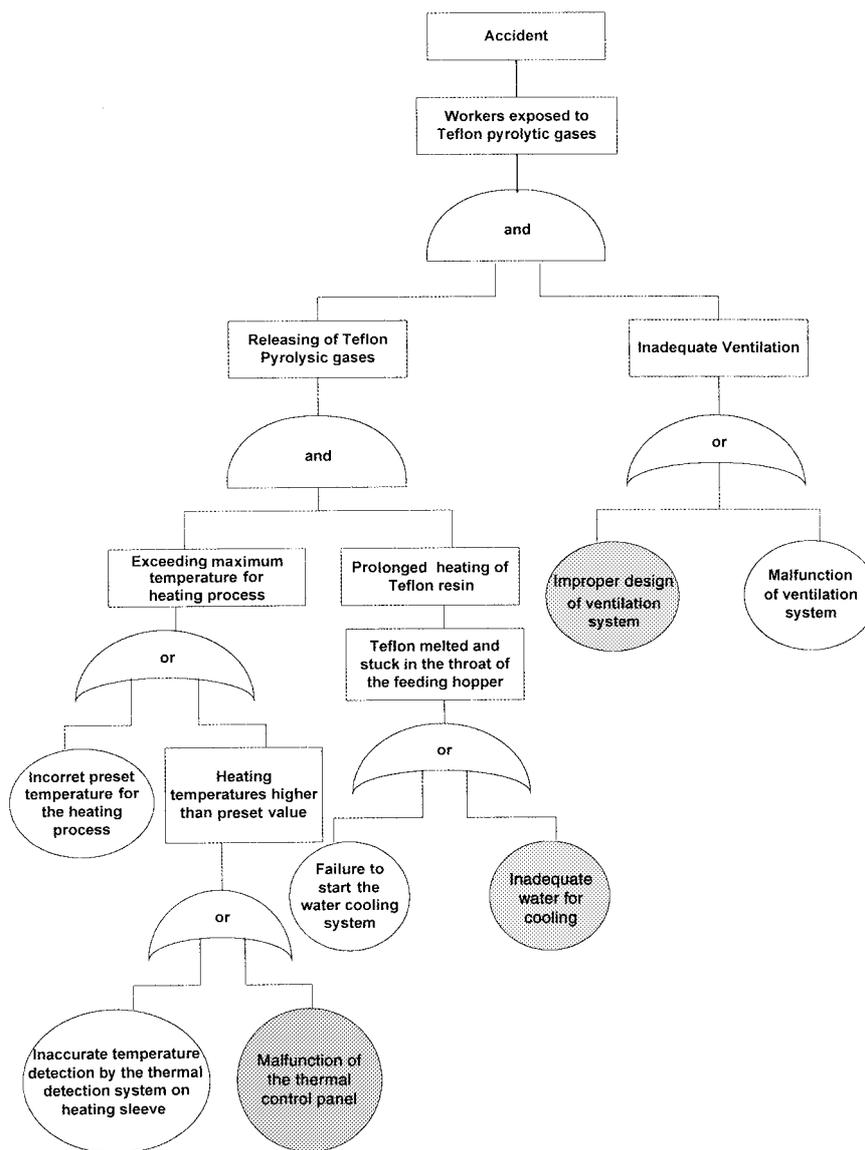
To find the causes of the accident, the logistic accident investigation technique of fault tree analysis (FTA) was adopted in this study. The technique involves first the identification of all possible cause elements (as seen at the bottom of the fault tree in Fig. 2), then grouping relevant cause elements to investigate intermediate cause elements via the logistic determination process, then repeating the above process until it reaches the occurrence of the accident scenario. The detailed FTA result for the given event is shown in Fig. 2. In this study, it should be noted here that the analysis of the causes of the event are not limited to those which are directly relevant to this special event. Instead, potential causes that might lead to the occurrence of similar exposure scenarios are taken into account. It is concluded that three basic causes (the cause elements with the hatched area) are found directly relevant to the event, including:

- (1) Improper design of the ventilation system.
- (2) Inadequate water supply for the cooling water system during the resin charging process.
- (3) Malfunction of the thermal control panel.

In addition, four potential causes (the cause elements with no hatched area), though not directly relevant to the event, might result in similar exposure scenarios, were found in this study, including:

- (1) Malfunction of the ventilation system.
- (2) Failure to start the cooling water system during the resin charging process.
- (3) Inaccurate temperature detection by the thermal detecting system.
- (4) Incorrect preset temperature for the heating process.

For practical reason, preventive strategies for those causes directly relevant to this fatal event are rated as first priority measures for the purpose of recommending the employer to take immediate action to prevent such an accident from happening again. Preventive strategies that are not directly relevant to the causes of the given event, but are relevant to the intrinsic safety of either the manufacturing process or facilities are rated as secondary

priority measures. Preventive strategies that are relevant to administrative control are rated as third priority measures. Detailed preventive strategies recommended by this study are shown in Table 2, including:

(1) First priority measures

- c. Periodically examining the function of the thermal control panel.

(2) Second priority measures

- a. Installing an interlock system to ensure that both the ventilation system and the heating process will be simultaneously started.
- b. Installing an interlock system to ensure that both the cooling water system and the Teflon resin charging process will be simultaneously started.
